Attachment No. 5
Exhibit C
Letters from the Building Official

Gordon J. Steuck
PLN080454

Re: Action on Appeal of Final Inspection Approval for Grading Permit No. GP090013
Notice of Intent to Rescind Final Inspection Approval and Permit

Subject: Restoration Grading Report

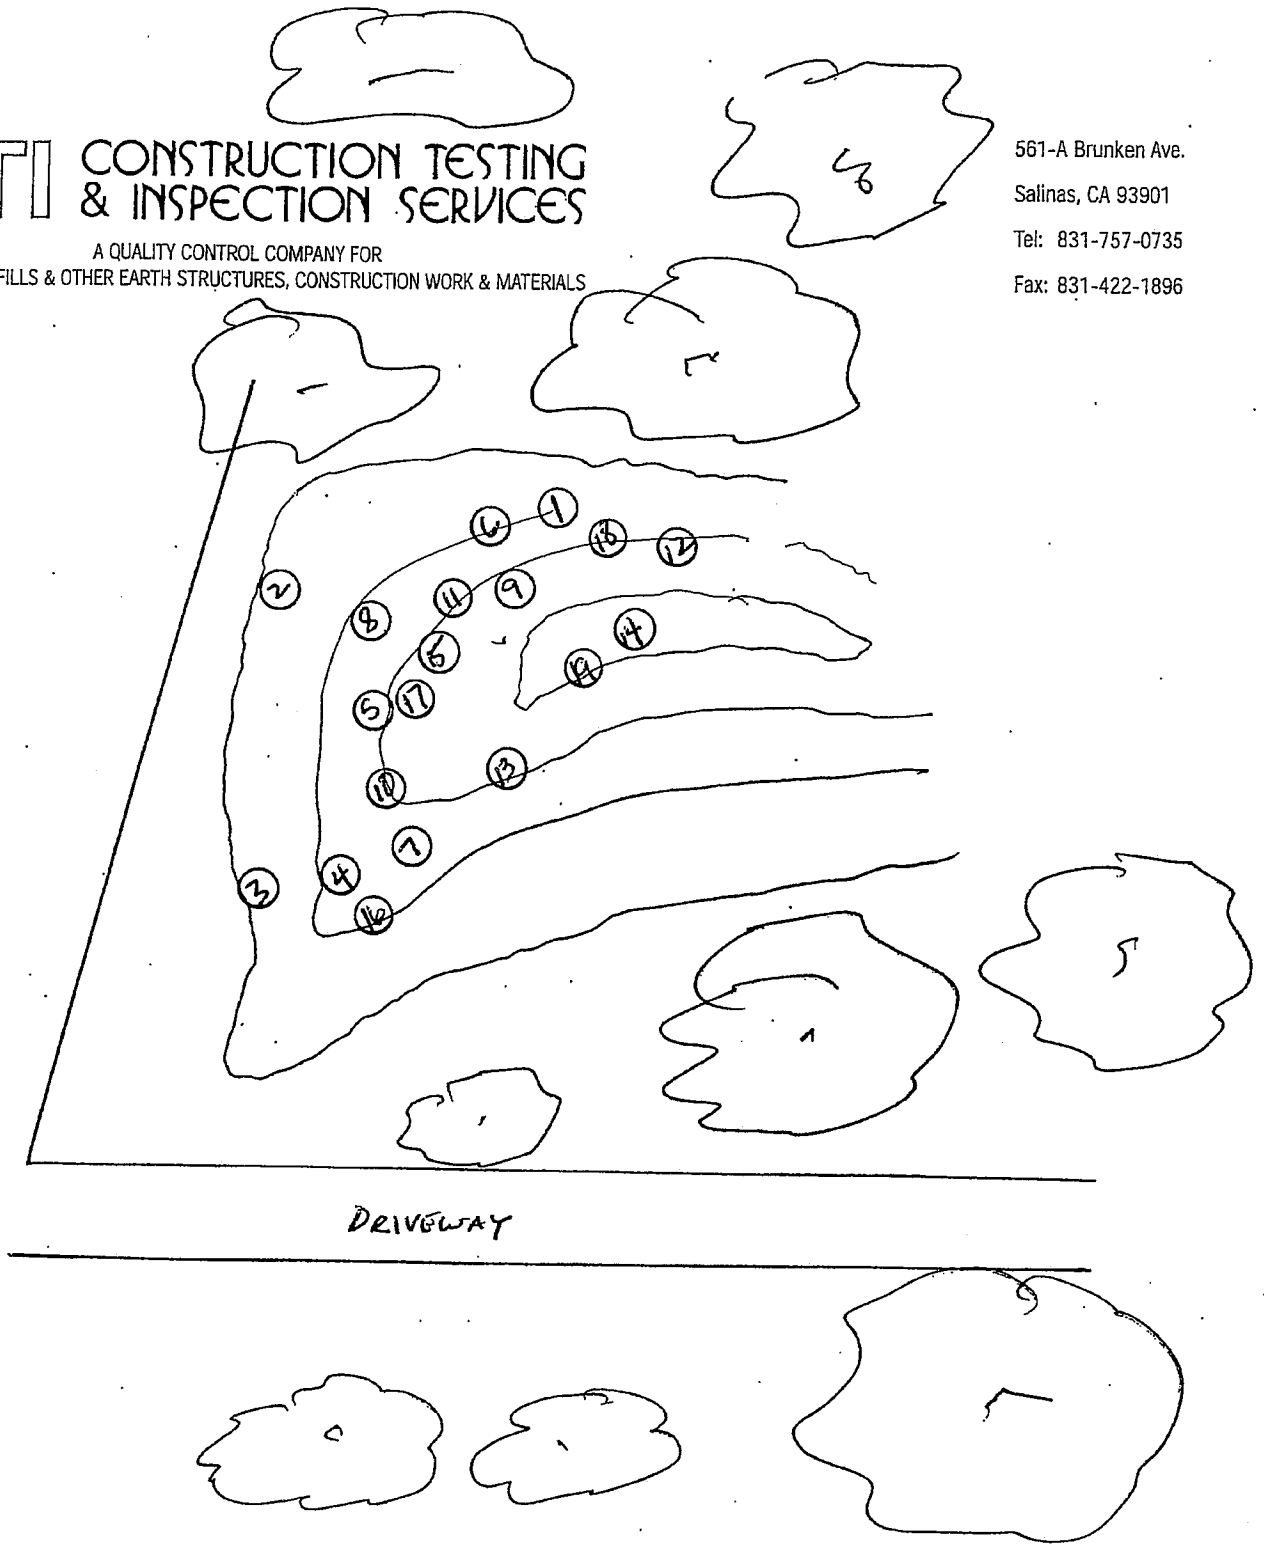
W.O. 1765
O=TEST LOC.
NO SCALE

DATE	NO.	LOCATION	ELEVATION	IN-PALCE WEIGHT	IN-PLACE MOISTURE	MAX. WEIGHT	OPTIMUM MOISTURE	RELATIVE DENSITY %
		See Sketch						
10/30/08	1	Site Restoration W Fill	-7	109.5	15.9	113.6	15	96.4%
10/30/08	2	Site Restoration W Fill	-7	110.5	14	113.6	15	97.3%
10/30/08	3	Site Restoration W Fill	-7	109	14.5	113.6	15	96.0%
10/31/08	4	Site Restoration W Fill	-5.5	108.9	16.5	113.6	15	95.9%
10/31/08	5	Site Restoration W Fill	-5.5	107.9	18.2	113.6	15	95.0%
10/31/08	6	Site Restoration W Fill	-5.5	106.5	18	113.6	15	93.8%
11/03/08	7	Site Restoration W Fill	-4	106.4	17.9	113.6	15	93.7%
11/03/08	8	Site Restoration W Fill	-4	107	17.5	113.6	15	94.2%
11/03/08	9	Site Restoration W Fill	-4	110	18.2	113.6	15	96.8%
11/03/08	10	Site Restoration W Fill	-3	110.2	18	113.6	15	97.0%
11/03/08	11	Site Restoration W Fill	-3	110	15	113.6	15	96.8%
11/03/08	12	Site Restoration W Fill	-3	109	14.4	113.6	15	96.0%
11/04/08	13	Site Restoration W Fill..	-1.5	109.3	15.5	115.9	13.2	94.3%

11/04/08	14	Site Restoration W Fill	-1.5	109.2	15.8	115.9	13.2	94.2%
11/04/08	15	Site Restoration W Fill	-1.5	109	16.2	115.9	13.2	94.0%
11/12/08	16	Site Restoration W Fill	FSG	110	16	115.9	13.2	94.9%
11/12/08	17	Site Restoration W Fill	FSG	111	15.2	115.9	13.2	95.8%
11/12/08	18	Site Restoration W Fill	FSG	110.5	15.6	115.9	13.2	95.3%
11/12/08	19	Site Restoration W Fill	FSG	110.5	115.2	115.9	13.2	95.3%
