**Mothball Plan
And Existing Conditions Survey
For
Fort Ord, East Garrison
Monterey, California**

March 14, 2006

*Prepared by
Architectural Resources Group,
Architects Planners & Conservators
San Francisco, California*

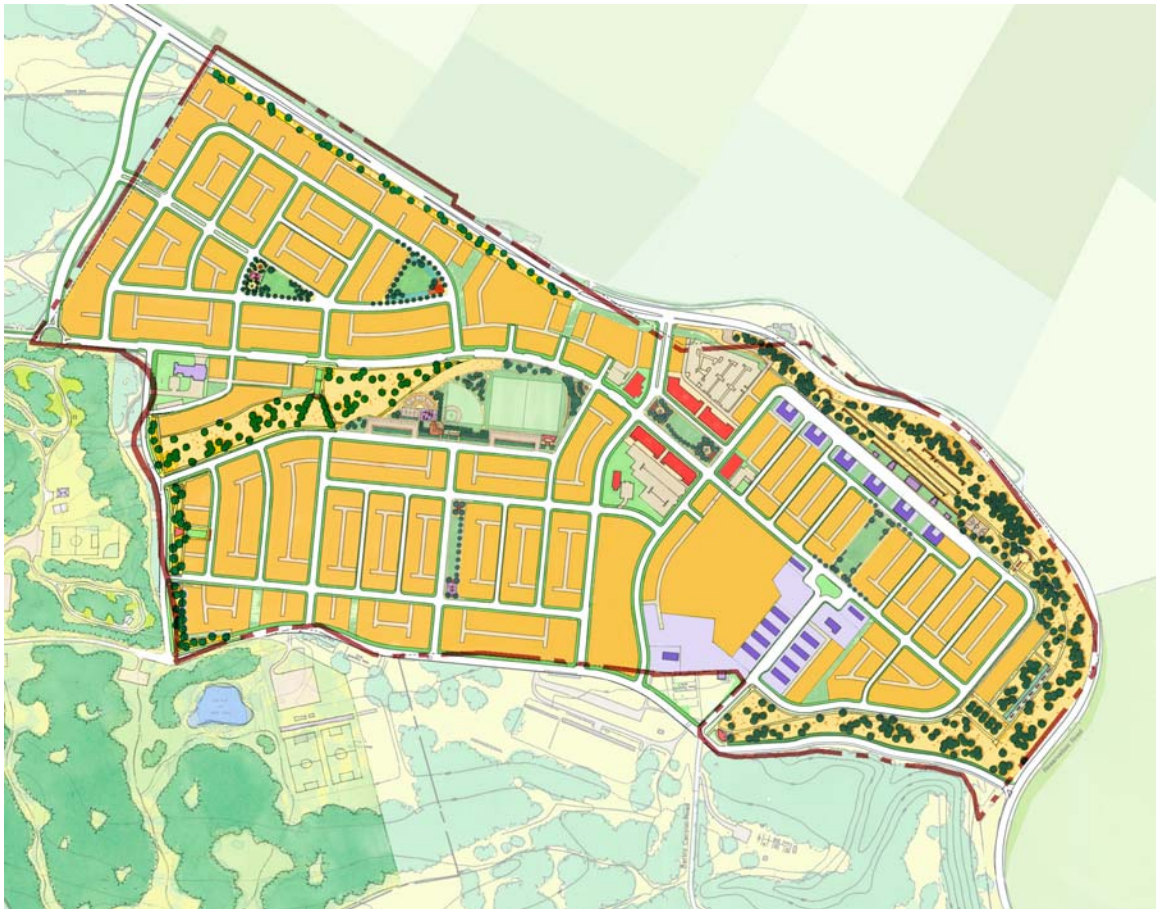
Figure 1: Master Plan of Fort Ord East Garrison. Structures designated for mothballing are highlighted in purple.

This report pertains to a select number of buildings at Fort Ord's East Garrison. The buildings include six of the Mess Halls, eight Warehouses, the Rod and Gun Club, two Latrines, the Exchange Branch Building (northeast of the Warehouses), two Officers Latrines, two Officers Mess Halls, and a concrete building located between the two Officers Mess Halls.
